AVIATION INVESTIGATION REPORT

A00H0002

LOSS OF SEPARATION

NAV CANADA
GANDER AREA CONTROL CENTRE
SYDNEY, NOVA SCOTIA 95 NM N
11 APRIL 2000

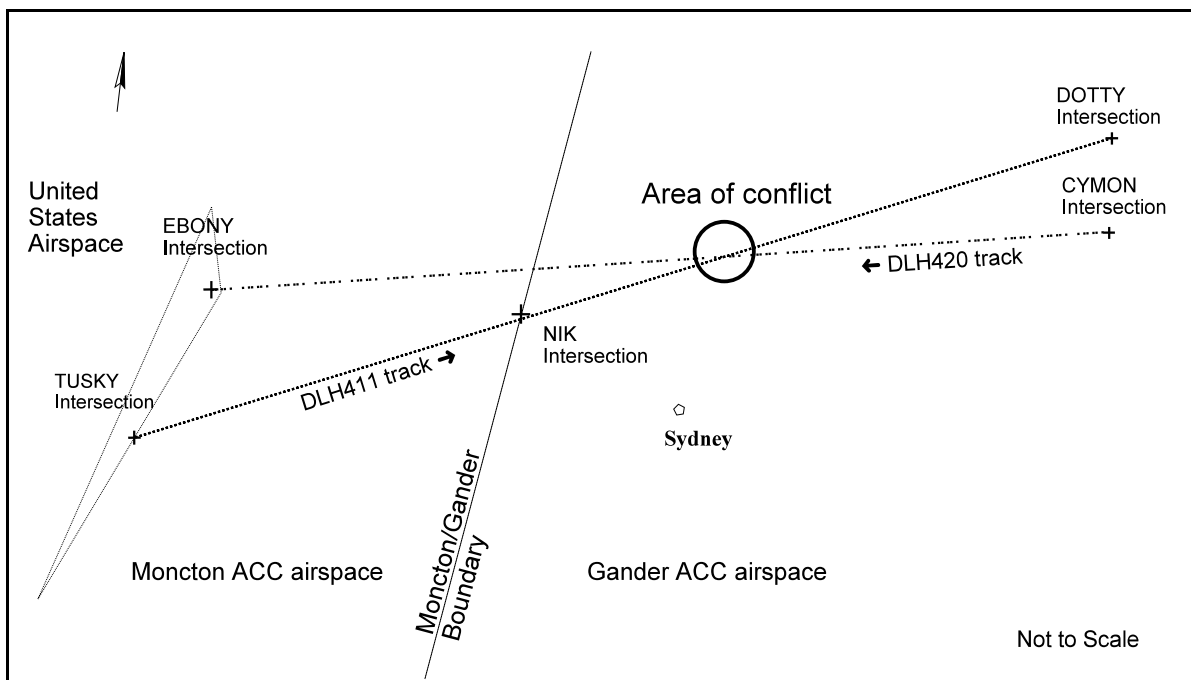
Figure 1 - Aircraft routing through Canadian domestic airspace

DLH411, also an Airbus A340, was on a flight from Newark International Airport, New Jersey, to Munich, Germany, and was routed through Canadian domestic airspace from TUSKY intersection direct to DOTTY intersection. This track would cross the track of DLH420 approximately 95 nautical miles (nm) north of Sydney, Nova Scotia. Moncton, New Brunswick, ACC initiated a radar handoff of DLH411 with the Gander domestic high (west) controller at
